WL-TR-92-3029

BIRD IMPACT RESISTANT ANALYSIS OF  
THE F-15E PRODUCTION TRANSPARENCY SYSTEM

Windshield Program Office  
Aircrew Protection Branch  
Wright-Patterson AFB OH 45433-6553

FINAL REPORT FOR 05/01/91 - 11/01/91

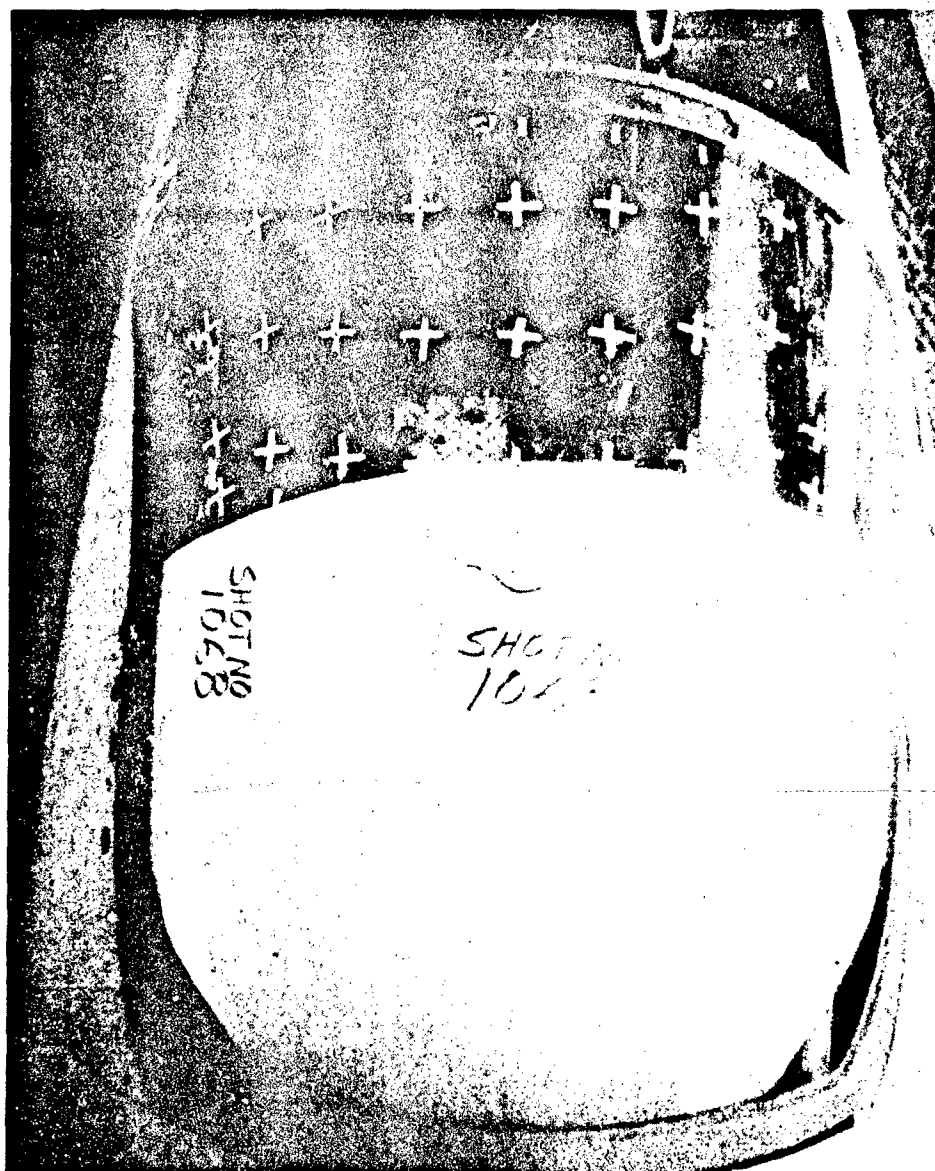
FIGURE 13

A 4-pound bird traveling at 426 knots impacted windshield S/N A41-0314 at the high quarter location. The impact resulted in the transparency system remaining structurally intact. Review of the high speed film confirmed that the windshield did contact the wire combiner glass silhouette during deflection. Post-inspection revealed scuff marks from the bird on the windshield and damage to the arch (Figure 13). The canopy arch and flange bent and cracked to absorb some energy of the deflecting windshield arch. The windshield arch separated enough from the canopy arch to allow several ounces of bird debris to enter the cockpit. Bird debris hit the forward camera, but both witness plates were unmarked. The bird scooped underneath the upper flange of the C-channel windshield arch and ripped a 10 inch section from the titanium arch. Test 1 was determined to be a "pass" after inspection of the test article and witness plates.

# TEST 1: SCUFF MARK, ARCH DAMAGE

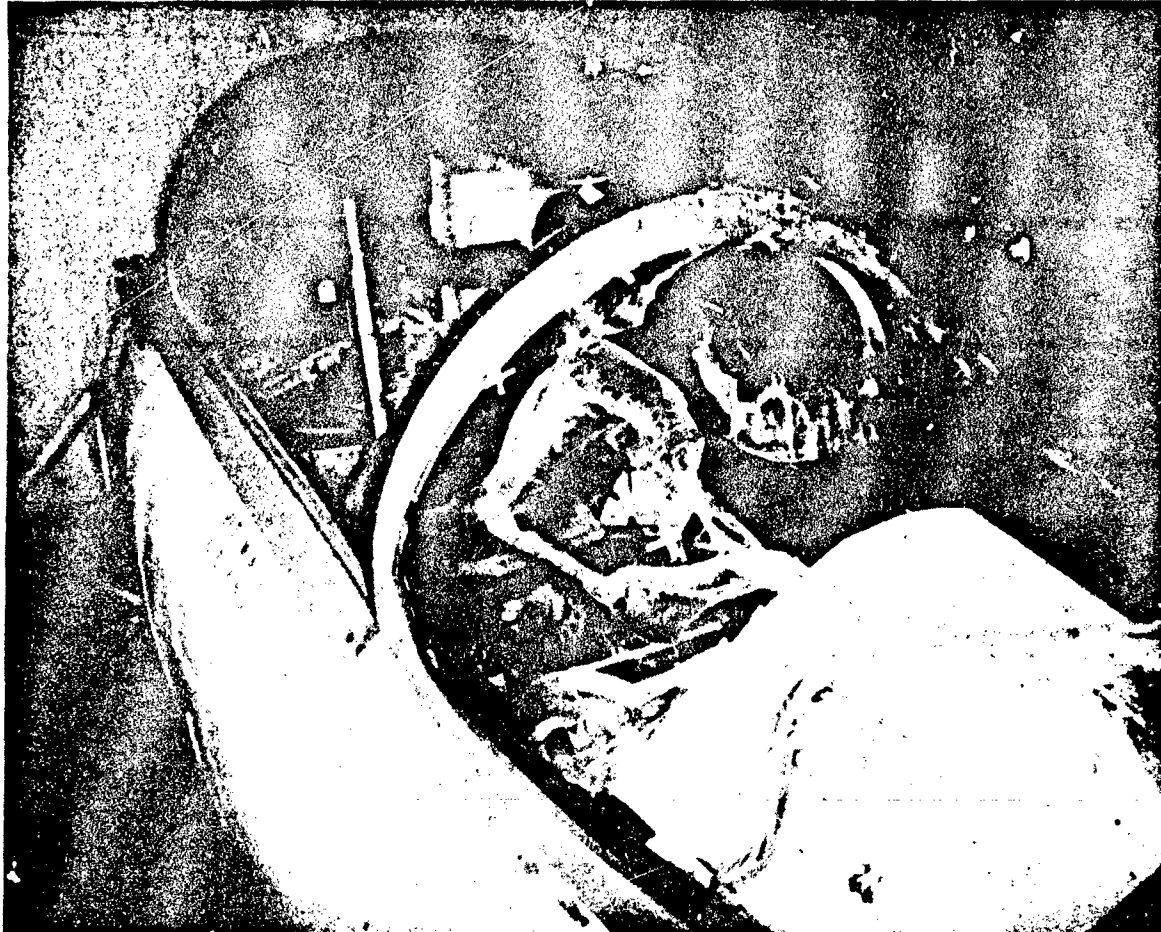
**FIGURE 14**

A 4-pound bird impacted the windshield high quarter at 427 knots resulting in catastrophic structural failure (Figure 14). Review of the high speed film revealed that the failure was initiated when the windshield contacted the combiner glass. The contact cracked the monolithic acrylic panel and shattered the combiner glass inward. The windshield panel rebounded outward splintering pieces of acrylic, some as large as 18 by 6 inch. A post-inspection revealed that bird, acrylic, and glass debris impacted the forward camera (Figure 15). The witness plates were slightly scratched, but remained intact. The canopy transparency cracked, pressurization was lost in the seal, and the forward arch flange bent downward. Test 2 was determined to be a "fail" due to structural failure and bird penetration.

**TEST 2:**

**WINDSHIELD FAILURE**

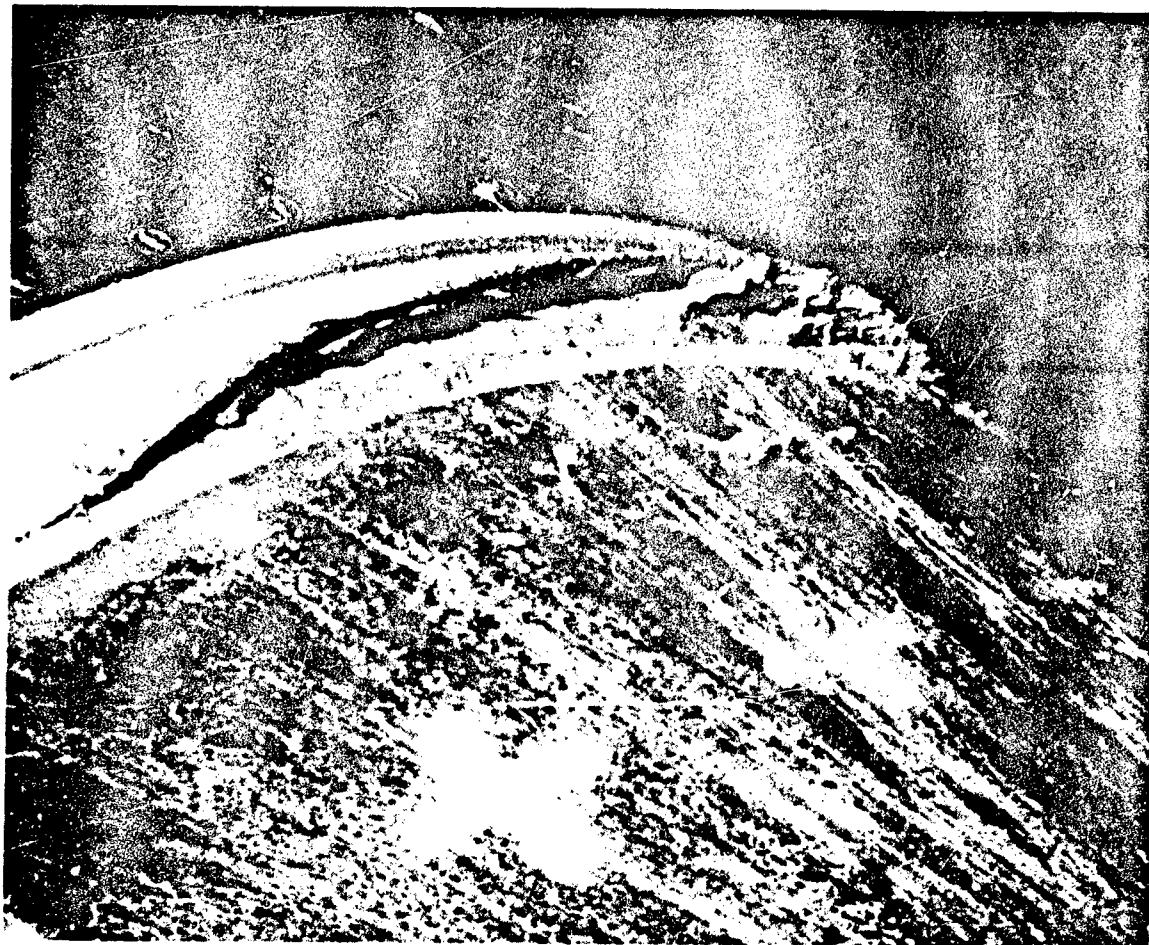
**FIGURE 16**

A 4-pound bird impacted the windshield high quarter location at 395 knots. The impact resulted in the transparency system remaining structurally intact. The windshield had scuff marks from the bird and sustained damage to the arch. The upper flange of the C-channel arch was peeled away from the acrylic (Figure 16). Review of the high speed film indicated that the windshield did contact the combiner glass, which oscillated after the impact. A post inspection revealed score marks on the inner windshield surface confirming that the HUD combiner glass contacted the windshield (Figure 17). Canopy seal pressurization was maintained. No bird debris penetrated the cockpit and the mirrors and compass remained intact. Test 3 was determined to be a "pass."

**TEST 3:  
ARCH FLANGE DAMAGE**

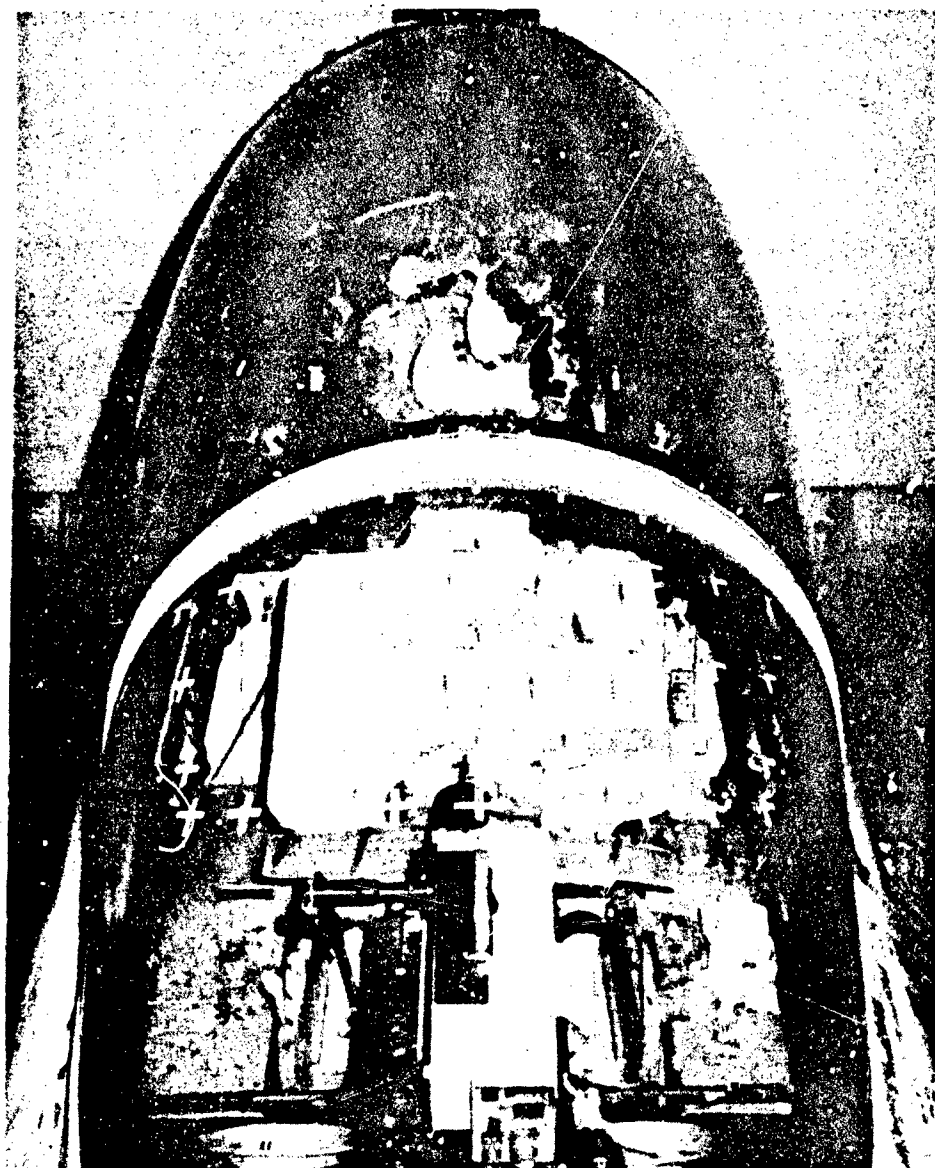
**FIGURE 18**

A 4-pound bird impacted the canopy at a speed of 496 knots resulting in damage to the simulated aircrew. A post-inspection revealed a 14 by 8 inch hole in the acrylic (Figure 18). The high speed film confirmed that the bird penetrated the monolithic acrylic and impacted the forward witness plate and ejection seat headrest (Figure 19). The ACESII ejection system did not interfere with the response of the canopy during bird impact. The forward seat shielded the aft crew member from bird debris and acrylic shards. However, the forward breaker bar detached, becoming a projectile that impacted the rear witness plate on the head (Figure 20). Test 4 was determined to be a "fail" due to bird penetration and heavy damage to the forward witness plate.

# **TEST 4: BIRD PENETRATION**

4.2 Recommendations The Strike Eagle spends over half its flight time in the bird environment (Figure 2), while traveling in excess of 400 knots for the better part of that time. However, the F-15E canopy is vulnerable to bird penetration at speeds above 170 knots and the windshield provides protection up to roughly 400 knots. The risk of a bird penetration resulting in fatality or loss of aircraft should be quantitatively defined. Birdstrike risk models have been formulated that predict the risk to a given aircraft configuration. The analysis should consider the test results mentioned in this report and historical birdstrike data on the F-15E aircraft as well as other aircraft which fly the low altitude high speed mission. Input data to the model includes fleet size, mission profile, flight hours, and bird population density.

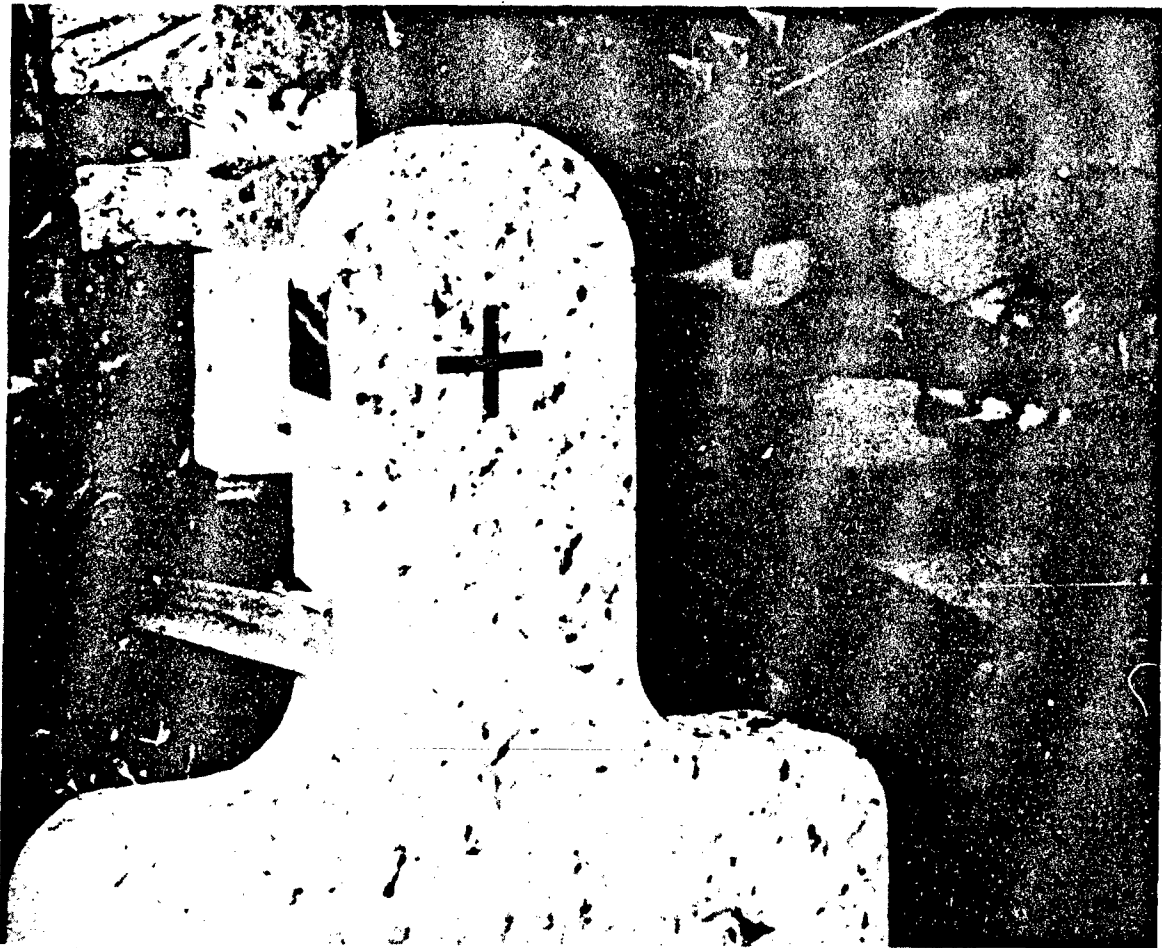
**FIGURE 20**

# **TEST 4: AFT WITNESS PLATE AND BREAKER BAR**

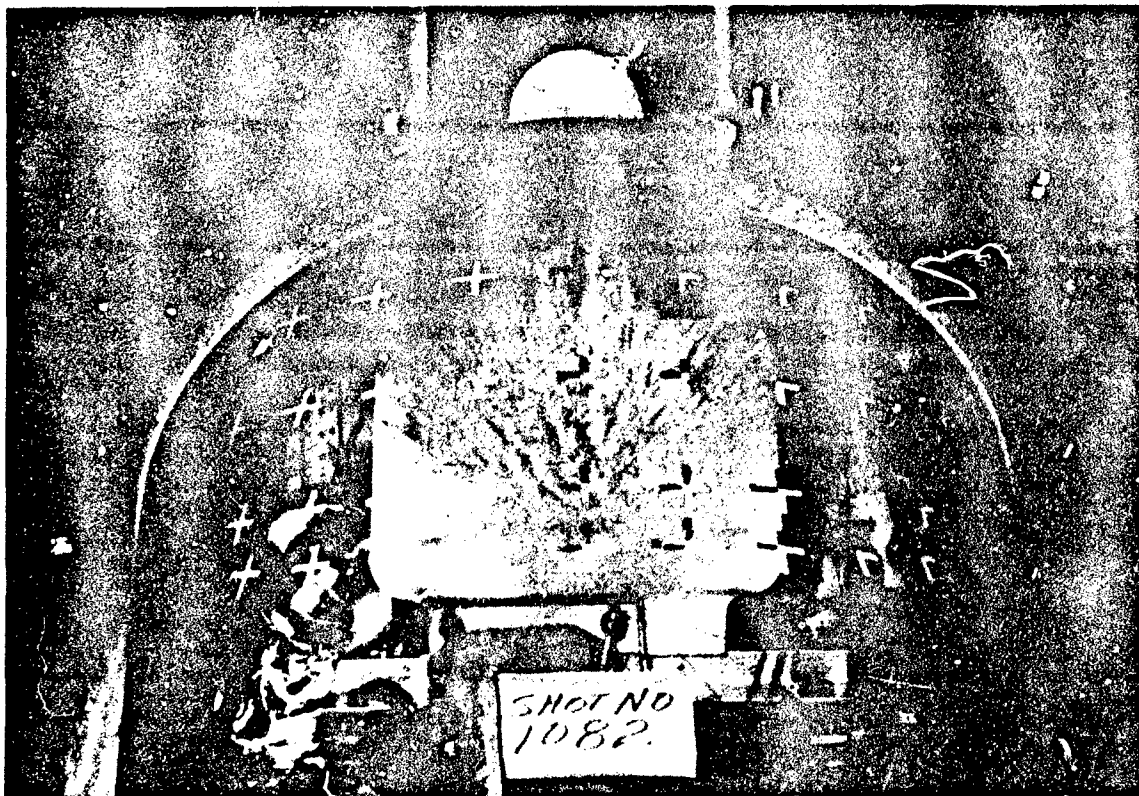
**FIGURE 21**

A 2-pound bird impacted the windshield high quarter location at 536 knots. The impact resulted in the windshield remaining structurally intact. A post-inspection revealed scuff marks on the windshield and minor arch damage (Figure 21). The result indicates that the selected conditions were below the impact tolerance of the system. Test 5 was determined to be a "pass."

**TEST 5:  
SCUFF MARK, ARCH DAMAGE**
